# **Rapid Stabilization of Thawing Soils for Enhanced Vehicle Mobility**

## **A Field Demonstration Project**

Maureen A. Kestler, Sally A. Shoop, Karen S. Henry,  
Jeffrey A. Stark, and Rosa T. Affleck

February 1999

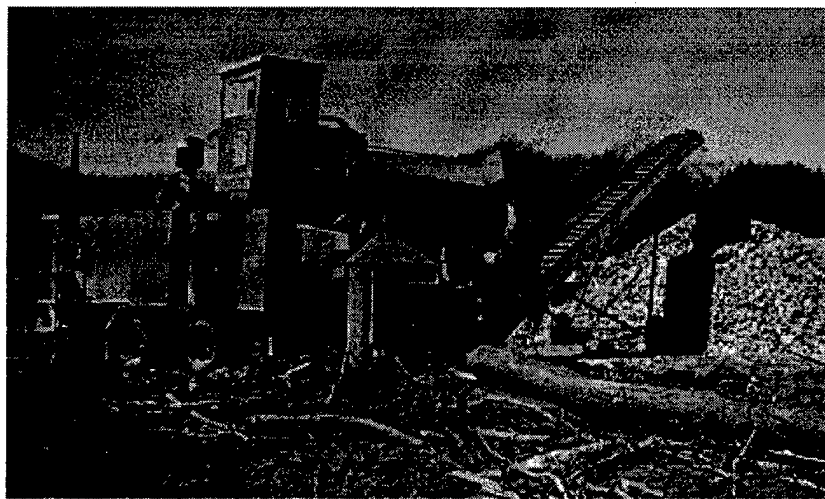
*Figure 8. Chunkwood.*

*a. Chunkwood fill.*

*b. USDA Forest Service wood chunker.*

The chunkwood was produced by shredding whole trees with a USFS prototype wood chunking machine. The resulting wood chunks were approximately 3.8 cm (1.5 in.) thick and were well graded, ranging from 1 to 20 cm (0.5 to 8 in.) in diameter. The chunkwood was mixed with sand in the approximate ratio of three parts chunkwood to one part sand. The density of the chunkwood/sand mix was approximately 796 kg/m<sup>3</sup> (50 lb/ft<sup>3</sup>). The bulking factor appeared to be low. Although testing by the USFS has shown a sheepsfoot or padfoot roller improves compaction, the chunkwood compacted easily with construction vehicle traffic. The compacted surface was relatively smooth and provided a good wear surface (Fig. 8).

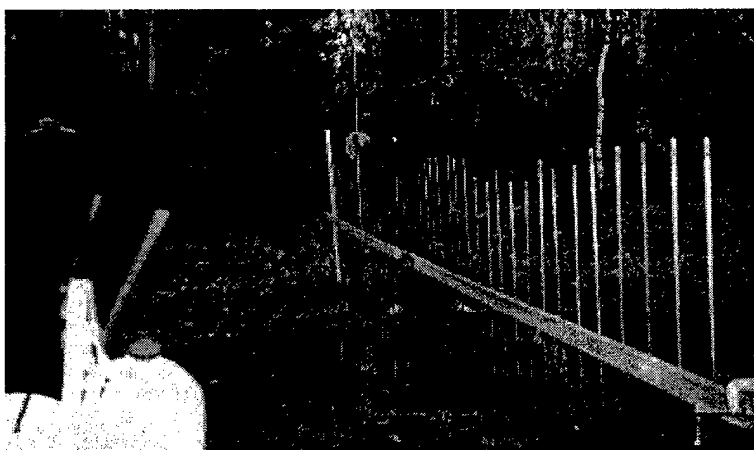
*c. Measuring rut depths manually.*

*Figure B5. Sampling and testing devices.*
